Using Thermography to Find a Class of Latent Construction Defects.

*Ken VanBree, Imaging Perspective, LLC
Scott Wood, Building Science Institute*

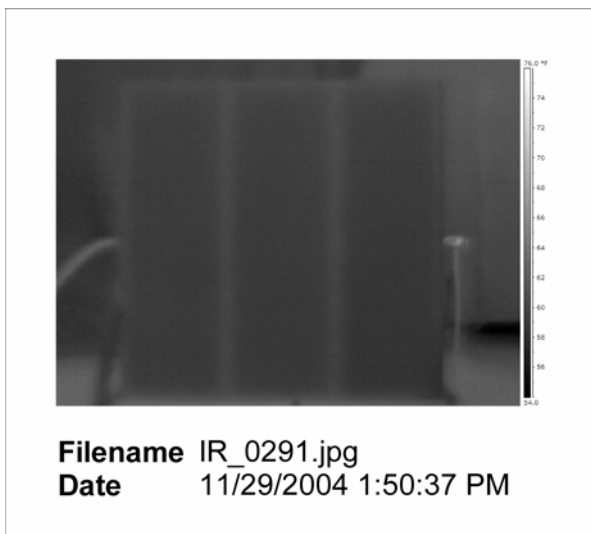
Filename IR_0291.jpg
Date 11/29/2004 1:50:37 PM

To test for construction defects we ran warm water through the in-wall plumbing. A FLIR B20 high-resolution thermal camera was set up on a tripod and recorded the thermal image at timed intervals. Figure 3 shows the thermal image of the wall in Figure 2 at the beginning of the test. In this test, a domestic water heater supplied water for the in-wall plumbing. The input water temperature was 100°F, and the wall and room were at 60° F. The 40°F temperature difference between the plumbing and the room caused the rock screws that were in contact with the water pipe to become heated and therefore clearly visible in 1.5 to 2 minutes. Image IR_0312 shown in Figure 4 shows a close-up of the center of the wall shown in image IR_0291 at the end of the thermal test. Three distinct hot spots representing sheet rock screws that in contact with the in-wall water pipe.

Figure 3 – Thermal image of wall before testing

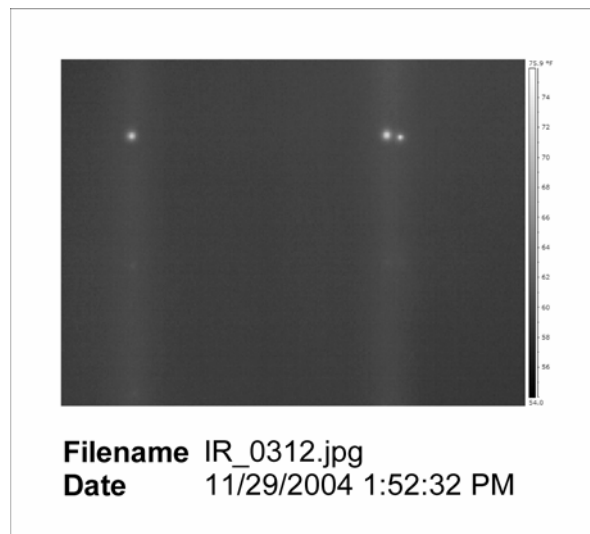
Filename IR_0312.jpg
Date 11/29/2004 1:52:32 PM

Figure 4 – Thermal image of center of wall after testing

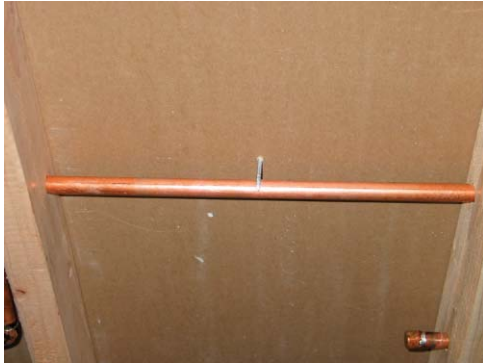
In order to test the robustness of the technique we conducted a number of additional experiments. The results show that the defects are still visible after taping and painting the wall. An additional screw was inserted through the sheet rock that contacted the copper pipe without penetrating it. Figure 5 shows the wall from the back with the screw clearly resting on the copper pipe. Figure 6 shows the resulting thermal image of the wall with the additional screw clearly visible. The “cooler” vertical stripe, as denoted by a dark color, is the result of fresh taping mud, cooling due to evaporation.

Figure 5 – Back of wall with center screw resting on pipe

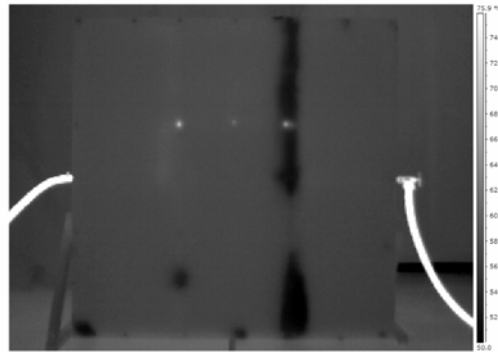
Filename IR_0490.jpg
Date 11/30/2004 3:07:50 PM

Figure 6 – Thermal image of wall with center screw

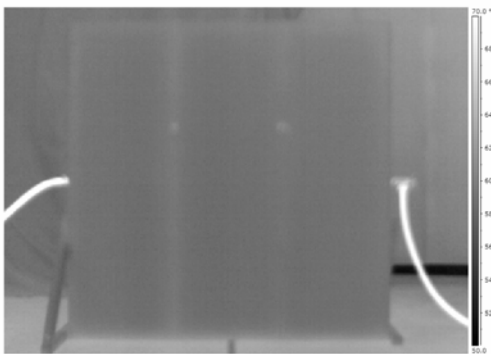
Filename IR_0346.jpg
Date 11/30/2004 12:08:08 PM

Figures 7 and 8 show the results of additional tests that are summarized in the above table. Notice the darkened area in Figure 8 that resulted from the cooling due to evaporation of water from the wet taping mud.

Figure 7 – Un-taped sheet rock, 20 °F temp. difference

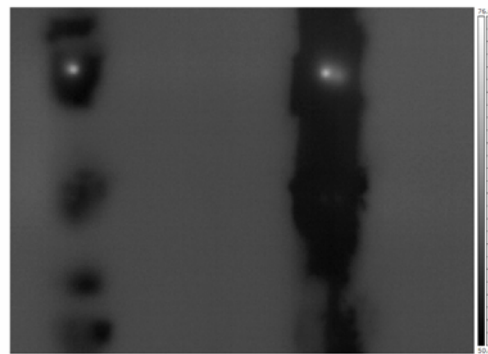
Filename IR_0390.jpg
Date 11/30/2004 12:45:54 PM

Figure 8 – Thermal image with wet taping mud on joints

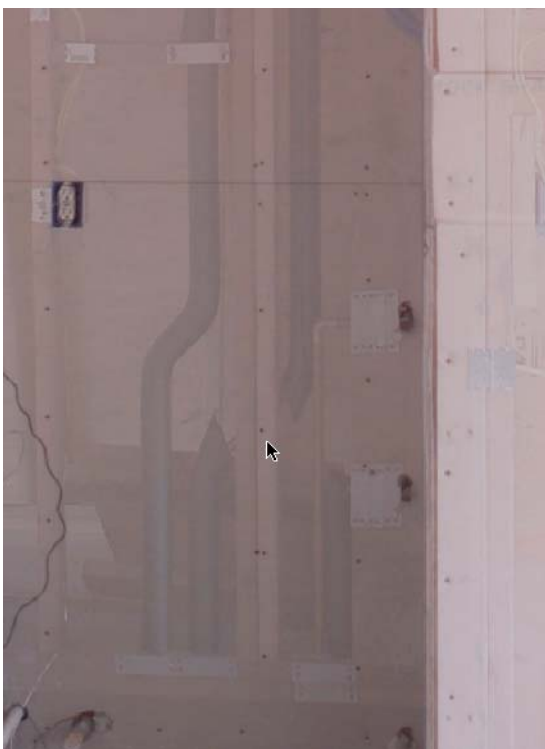
The test wall convinced us that it was feasible to test for screw-in-pipe defects in ongoing construction projects. The next step was to try the techniques on a construction site. Imaging Perspective, LLC has developed techniques for visually locating sheet-rock screws that are close enough to water pipes to cause concern. Figure 9 shows one such situation where a sheet-rock screw has been installed into a double stud through which a copper water-supply pipe is routed. From the visual image it appears that the screw could penetrate the pipe if the pipe is off center in the stud.

Figure 9 – “X-Ray” view of nail (at arrow) near insulated copper water pipe passing through double stud.

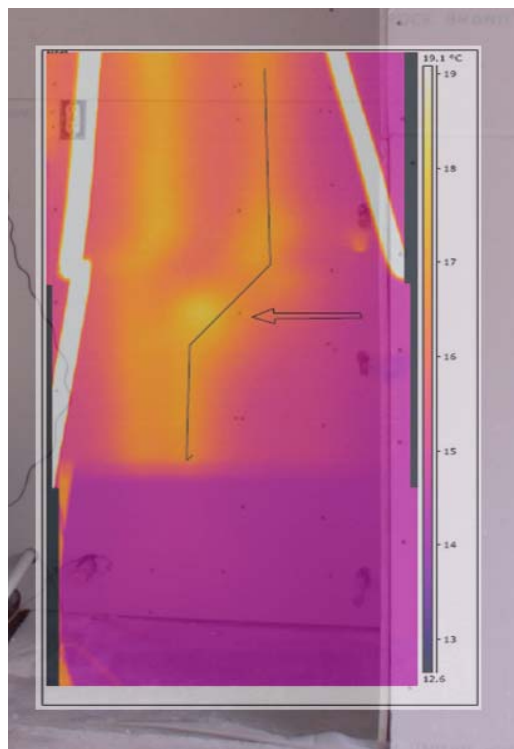
Figure 10 – Thermal overlay of nail (at arrow) near water pipe. Centerline of pipe marked by black jagged line.

Figure 10 shows an infrared thermogram superimposed over the area shown in Figure 9. The arrow in Figure 10 points to the same nail indicated by the arrow in Figure 9. The thermographer highlighted the centerline of the pipe that can be seen passing through the double stud in Figure 9. From the infrared thermogram it is clear that the nail is offset from the centerline of the water pipe far enough that there is little probability that it has contacted the pipe. In addition the temperature of the nail was determined to be half way between the temperature of the pipe conducting through the plaster and the ambient temperature of the wall. This is consistent with the screw reaching a thermal equilibrium while imbedded in a thermal insulator (wood) between a heat source (the pipe) and a heat sink (air). Our conclusion in this

case was that the screw in question had not come in contact with the water pipe and was not a potential latent construction defect.

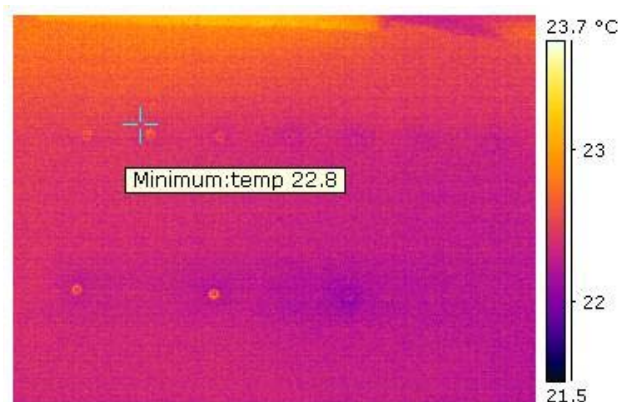
In order to further test the thermal properties of screws near but not touching water pipes we built a jig that allowed us to test the heating effect on screws imbedded in wood at various distances from a heat source, the hot pipe. The jig is shown schematically in Figure 11. A metal pipe was inserted at an angle through a 2x4 and sheet rock screws inserted throughout the length of the pipe. The first four screws, left to right, penetrated the pipe while the other three stopped short of touching the pipe. The jig is shown visibly in Figure 12. Impedance of the screws touching or penetrating the pipe was tested, confirming contact with the metal pipe. Tap water from a hot water line was run through the metal pipe. After one minute into the test, the temperature of the screws started to increase from 23°C to an eventual 33.7°C, 40 minutes into the test. Infrared thermograms of the jig are shown in Figures 13 and 14.

Figure 13 – Infrared Thermogram showing the screw temperature at the start of the test.

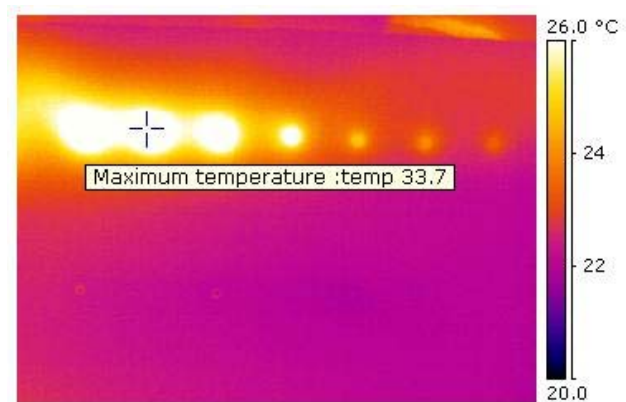
Figure 14 – Infrared Thermogram showing the maximum temperature, 40 minutes into the test
